Manhole Inspection Summary

Manhole # S67U__016MH

Record Plat: **67U** Node: **016** Status: **Other (Specify in comment)** Insp Date: **3/13/08 2:09 PM**

Location Address: **1700 Charlotte Ave.**

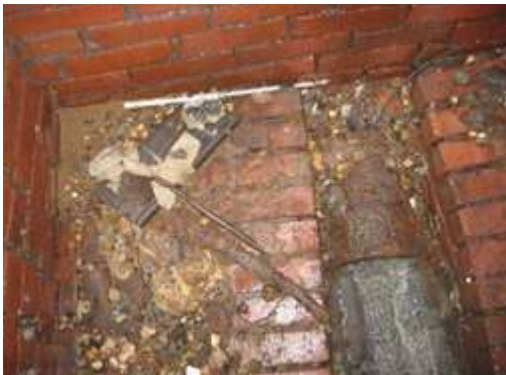
Defect 1

Condition: ☐ Sound ☐ Cracked ☐ Root Intrusion ☐ Deteriorated ☐ Leaks ☒ **Debris**

Debris on bench.

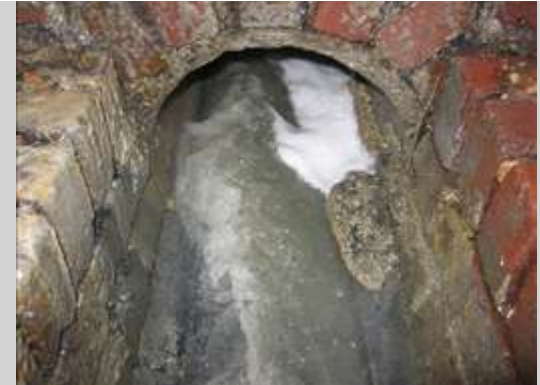
12 O'Clock Outflow

Pipe Height: **12** (in.) Rod and Bar (Angled)
Pipe Material: **Clay** ☐ Pipe Lined
Invert Depth: **15.50** (ft.) Flow Characteristics: **Fast**
Deposits: ☐ None ☐ Mud ☒ Sludge ☒ Debris ☐ Grease
Silt Depth: **4** (in.) Deposits Extent: **Heavy**
Infiltration: **None** Pipe Seal Cond: **Sound**

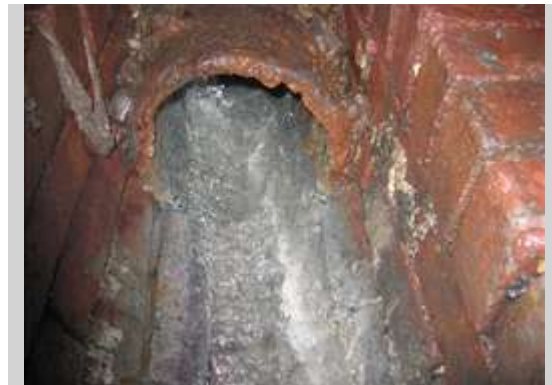
Drop In @ 3 O'Clock

Shared drop for the I3 and I9.

Drop: **Inside** Rod and Bar
Angled: **Yes** Reading: **14.33** (ft.)
Inv Depth: **15.33** (ft.)
Drop Condition: **Open**

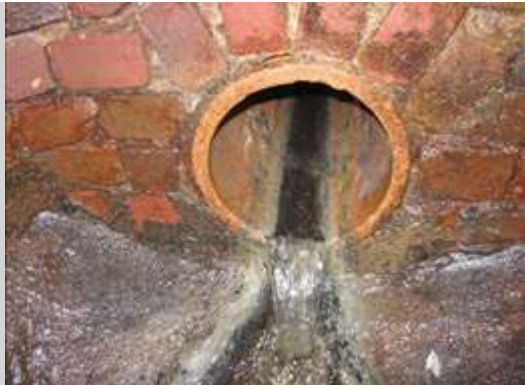
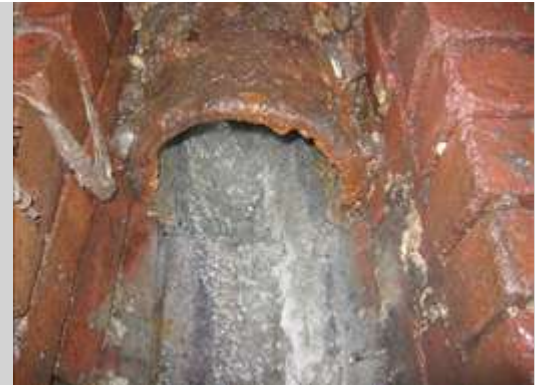
9 O'Clock Inflow

Shared drop for the I3 and I9.
